# **ANALYSIS FOR BROWNFIELDS CLEANUP ALTERNATIVES FOR THE FIRST NATIONAL CENTER ABATEMENT PROJECT**

**First National Center  
120 North Robinson  
Oklahoma City, Oklahoma**

**February 6, 2017**

**SCS Engineers and Family Environmental Services**

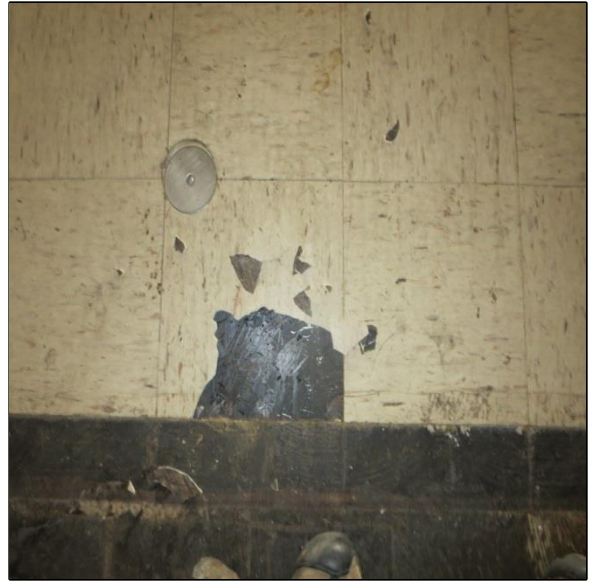
<b>Photograph Number:</b>	1	<b>Date:</b>	11/17/2016	<b>Photograph Number:</b>	2	<b>Date:</b>	11/17/2016
<b>Description:</b>	Asbestos-containing tan 9"x9" floor tile with black mastic on the 14 <sup>th</sup> floor. Samples 1, 2, 3.			<b>Description:</b>	Asbestos-containing white 12"x12" floor tile with black mastic on the 13 <sup>th</sup> floor. Samples 28, 29, 30.		
<b>Client:</b>	City of Oklahoma City, OK			<b>Client:</b>	City of Oklahoma City, OK		
<b>Photographer:</b>	Michael Dustman			<b>Photographer:</b>	Michael Dustman

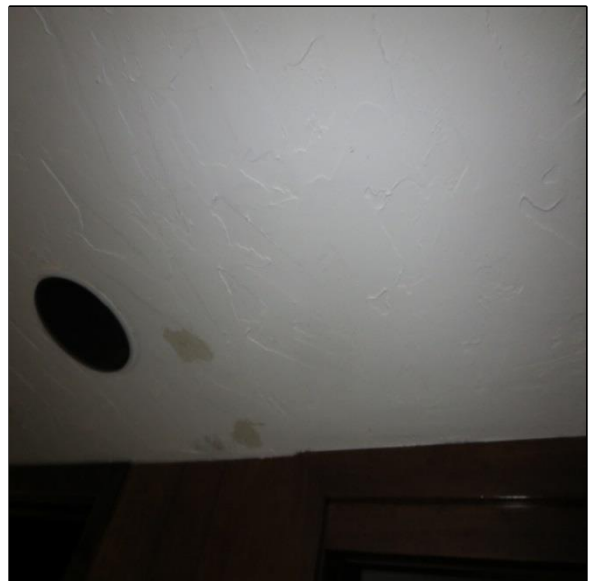
<b>Photograph Number:</b>	3	<b>Date:</b>	11/17/2016	<b>Photograph Number:</b>	4	<b>Date:</b>	11/17/2016
<b>Description:</b>	Asbestos-containing white wall texture on the 12 <sup>th</sup> floor. Samples 49, 50, 51.			<b>Description:</b>	Asbestos-containing white ceiling texture on the 12 <sup>th</sup> floor. Samples 52, 53, 54.		
<b>Client:</b>	City of Oklahoma City, OK			<b>Client:</b>	City of Oklahoma City, OK		
<b>Photographer:</b>	Michael Dustman			<b>Photographer:</b>	Michael Dustman

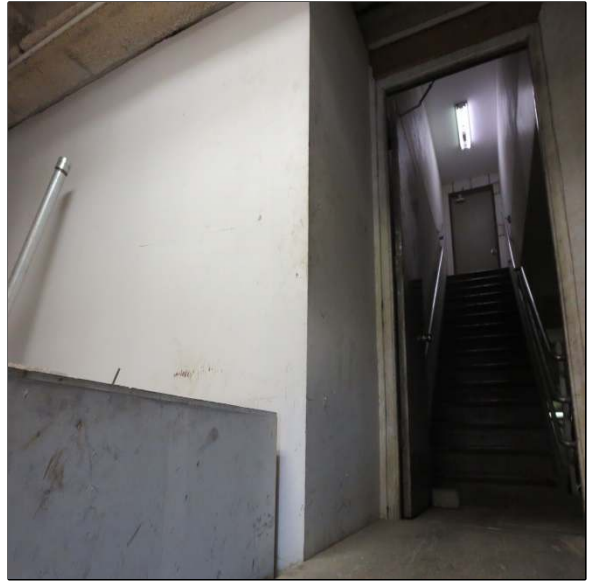
<b>Photograph Number:</b>	1	<b>Date:</b>	11/15/2016	<b>Photograph Number:</b>	2	<b>Date:</b>	11/15/2016
<b>Description:</b>	Asbestos-containing joint compound on drywall in elevator penthouse. Samples #4, 7, 8, 9.			<b>Description:</b>	Asbestos-containing surfacing material on air duct drywall on 14 <sup>th</sup> floor. Samples #13, 14, 15.		
<b>Client:</b>	City of Oklahoma City, OK			<b>Client:</b>	City of Oklahoma City, OK		
<b>Photographer:</b>	Michael Dustman			<b>Photographer:</b>	Michael Dustman

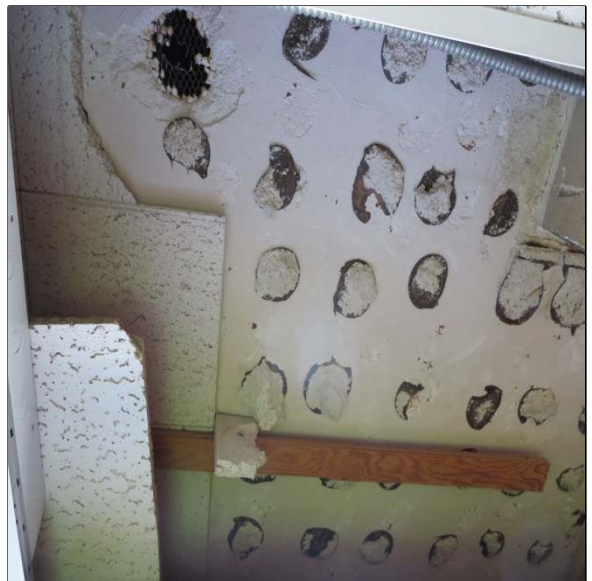
<b>Photograph Number:</b>	3	<b>Date:</b>	11/15/2016	<b>Photograph Number:</b>	4	<b>Date:</b>	11/15/2016
<b>Description:</b>	Asbestos-containing tan 9"x9" floor tile with black mastic on the 11 <sup>th</sup> floor. Samples 43, 44, 45.			<b>Description:</b>	Asbestos-containing black glue dots on the 11 <sup>th</sup> floor. Samples 49, 50, 51.		
<b>Client:</b>	City of Oklahoma City, OK			<b>Client:</b>	City of Oklahoma City, OK		
<b>Photographer:</b>	Michael Dustman			<b>Photographer:</b>	Michael Dustman

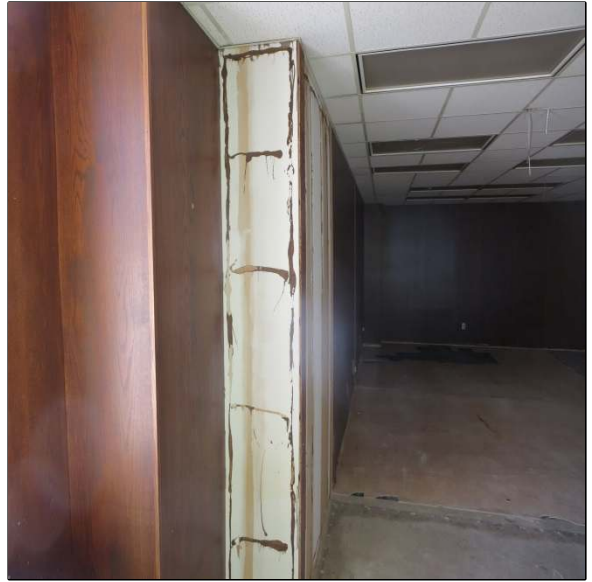
<b>Photograph Number:</b>	5	<b>Date:</b>	11/15/2016	<b>Photograph Number:</b>	6	<b>Date:</b>	11/15/2016
<b>Description:</b>	Asbestos-containing black mastic under gray floor filler on the 11 <sup>th</sup> floor. Samples 52, 53, 54.			<b>Description:</b>	Asbestos-containing brown mastic behind wood paneling on the 11 <sup>th</sup> floor. Samples 55, 56, 57.		
<b>Client:</b>	City of Oklahoma City, OK			<b>Client:</b>	City of Oklahoma City, OK		
<b>Photographer:</b>	Michael Dustman			<b>Photographer:</b>	Michael Dustman

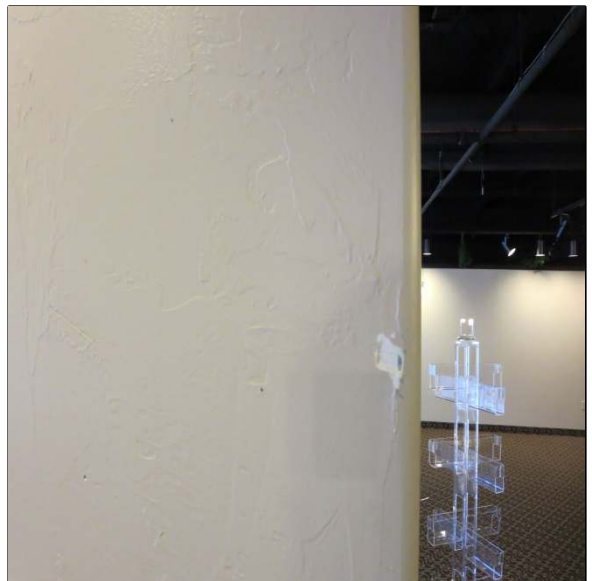
<b>Photograph Number:</b>	7	<b>Date:</b>	11/15/2016	<b>Photograph Number:</b>	8	<b>Date:</b>	11/16/2016
<b>Description:</b>	Asbestos-containing black mastic under gray floor filler on the 7 <sup>th</sup> floor. Samples 61, 62, 63.			<b>Description:</b>	Asbestos-containing texture on a wall in Feed the Children on the 1 <sup>st</sup> floor. Sample 117.		
<b>Client:</b>	City of Oklahoma City, OK			<b>Client:</b>	City of Oklahoma City, OK		
<b>Photographer:</b>	Michael Dustman			<b>Photographer:</b>	Michael Dustman

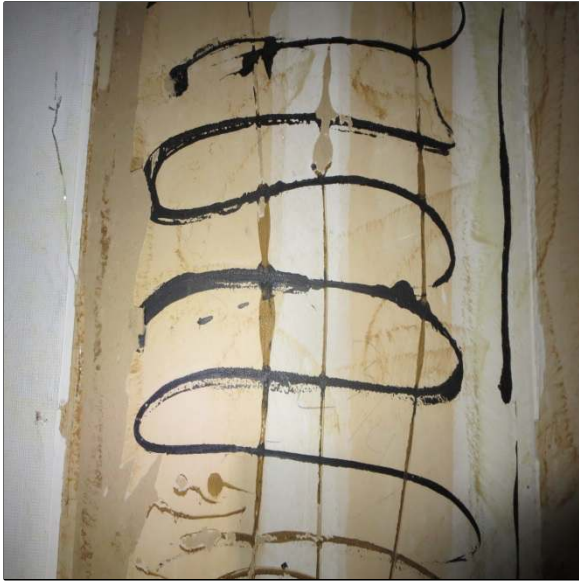
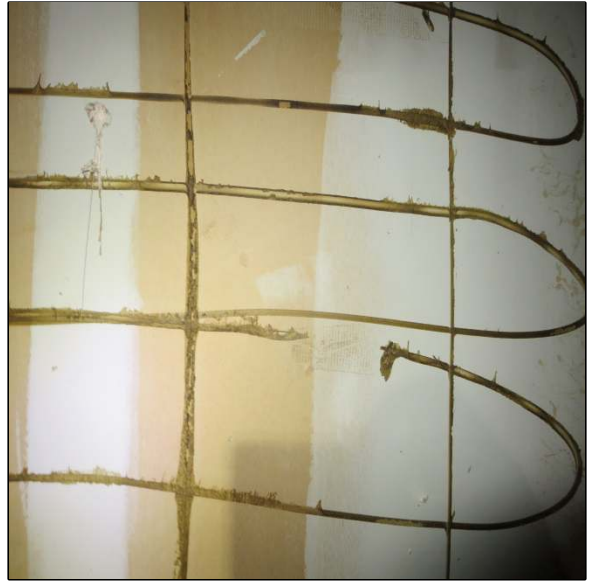
<b>Photograph Number:</b>	9	<b>Date:</b>	11/16/2016	<b>Photograph Number:</b>	10	<b>Date:</b>	11/16/2016
<b>Description:</b>	Asbestos-containing black mastic behind wood paneling in the basement. Samples 172, 173, 174.			<b>Description:</b>	Asbestos-containing brown mastic behind wood paneling in the basement. Samples 175, 176, 177.		
<b>Client:</b>	City of Oklahoma City, OK			<b>Client:</b>	City of Oklahoma City, OK		
<b>Photographer:</b>	Michael Dustman			<b>Photographer:</b>	Michael Dustman

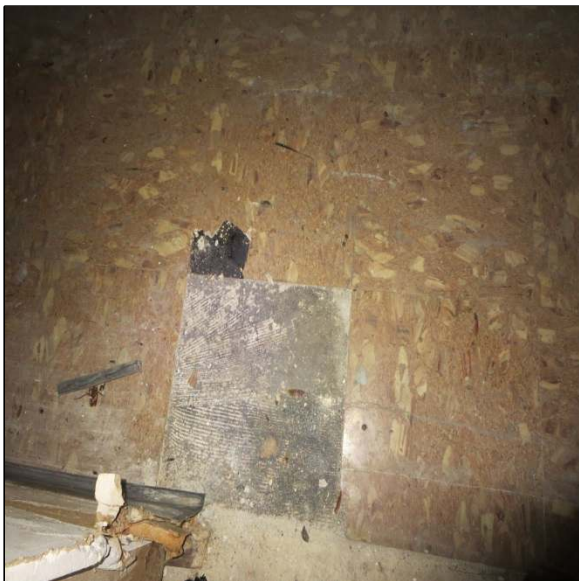
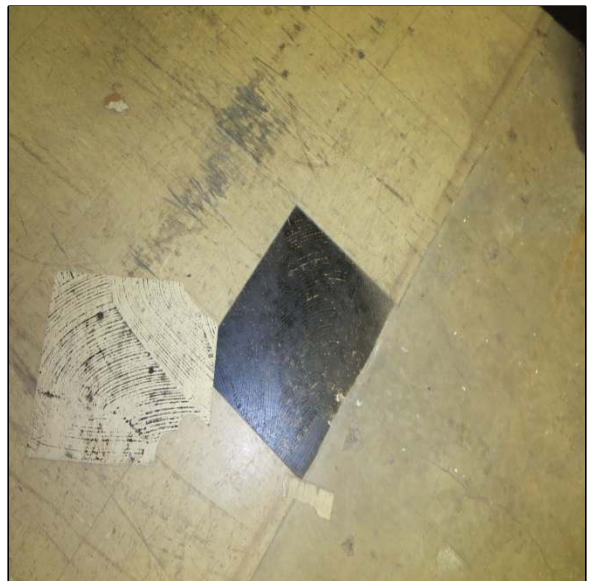
<b>Photograph Number:</b>	11	<b>Date:</b>	11/16/2016	<b>Photograph Number:</b>	12	<b>Date:</b>	11/16/2016
<b>Description:</b>	Asbestos-containing black mastic under brown floor tile in the basement. Samples 178, 179, 180.			<b>Description:</b>	Asbestos-containing black mastic under off-white floor tile in the basement. Samples 181, 182, 183.		
<b>Client:</b>	City of Oklahoma City, OK			<b>Client:</b>	City of Oklahoma City, OK		
<b>Photographer:</b>	Michael Dustman			<b>Photographer:</b>	Michael Dustman

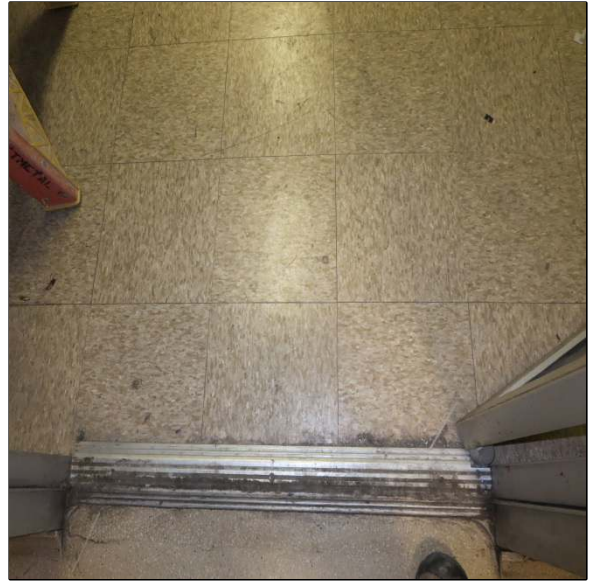
<b>Photograph Number:</b>	13	<b>Date:</b>	11/16/2016	<b>Photograph Number:</b>	14	<b>Date:</b>	11/16/2016
<b>Description:</b>	Asbestos-containing black mastic under tan with red streaked floor tile in the basement. Samples 196, 197, 198.			<b>Description:</b>	Asbestos-containing black mastic under tan with tan streaked floor tile in the basement. Samples 199, 200, 201.		
<b>Client:</b>	City of Oklahoma City, OK			<b>Client:</b>	City of Oklahoma City, OK		
<b>Photographer:</b>	Michael Dustman			<b>Photographer:</b>	Michael Dustman

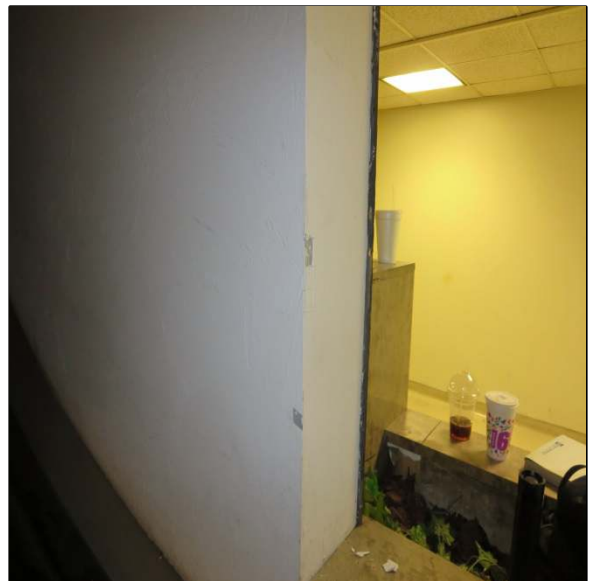
<b>Photograph Number:</b>	15	<b>Date:</b>	11/16/2016	<b>Photograph Number:</b>	16	<b>Date:</b>	11/16/2016
<b>Description:</b>	Asbestos-containing black mastic under gray floor tile in the basement. Samples 217, 218, 219.			<b>Description:</b>	Asbestos-containing texture on a wall by the basement escalator. Samples 226, 227, 228.		
<b>Client:</b>	City of Oklahoma City, OK			<b>Client:</b>	City of Oklahoma City, OK		
<b>Photographer:</b>	Michael Dustman			<b>Photographer:</b>	Michael Dustman

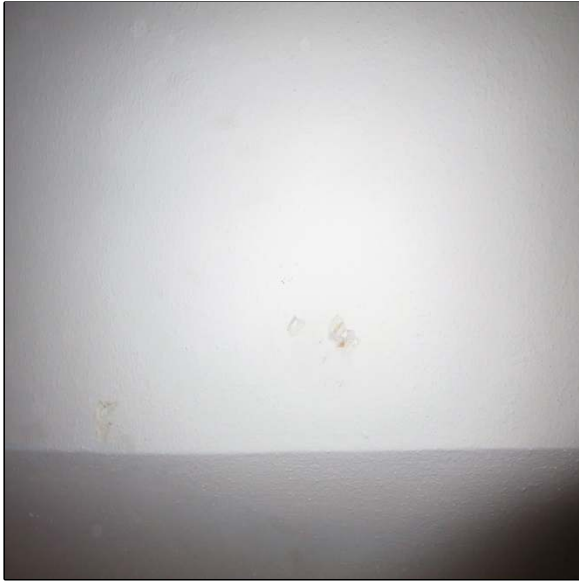
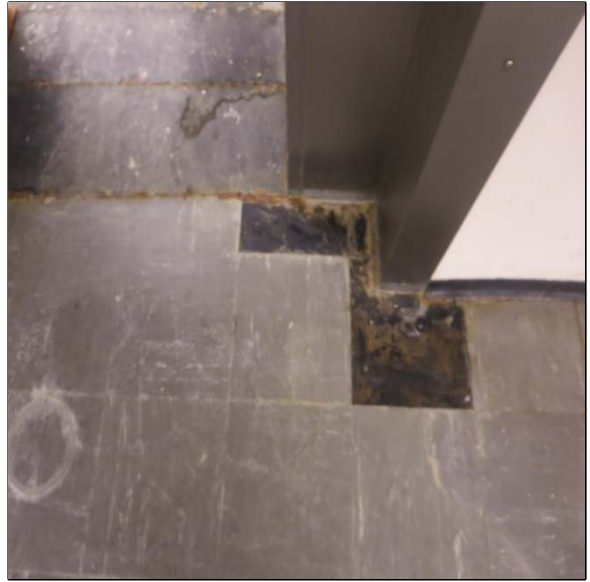
<b>Photograph Number:</b>	17	<b>Date:</b>	11/16/2016	<b>Photograph Number:</b>	18	<b>Date:</b>	11/16/2016
<b>Description:</b>	Asbestos-containing texture on a ceiling by the basement escalator. Samples 229, 230, 231.			<b>Description:</b>	Asbestos-containing gray floor tile with black mastic in the sub-basement. Samples 232, 233, 234.		
<b>Client:</b>	City of Oklahoma City, OK			<b>Client:</b>	City of Oklahoma City, OK		
<b>Photographer:</b>	Michael Dustman			<b>Photographer:</b>	Michael Dustman

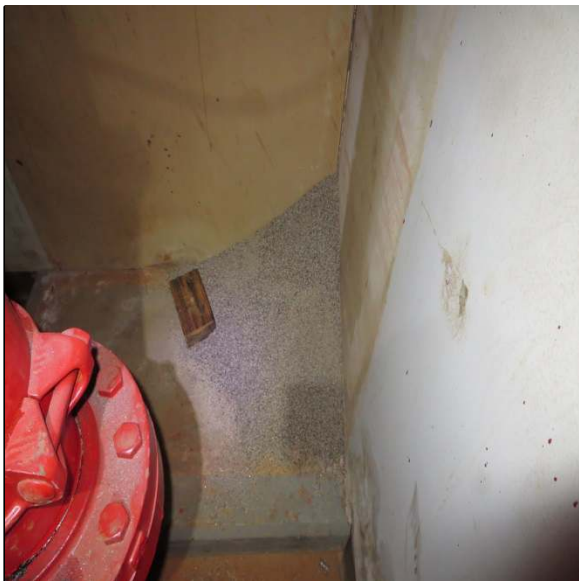
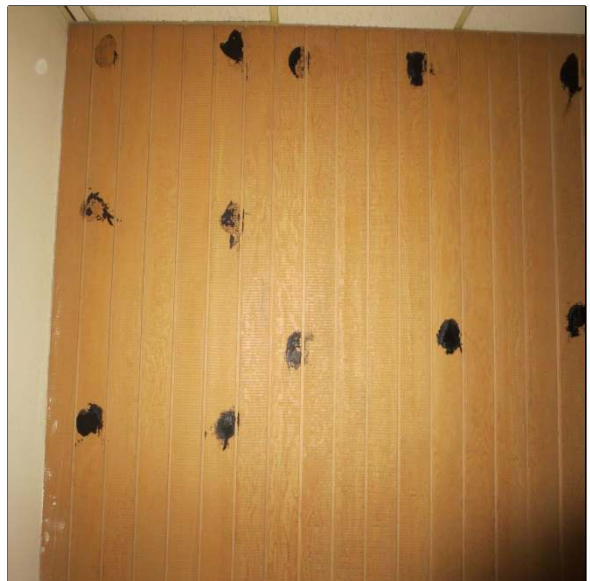
<b>Photograph Number:</b>	19	<b>Date:</b>	11/16/2016	<b>Photograph Number:</b>	20	<b>Date:</b>	11/16/2016
<b>Description:</b>	Asbestos-containing vermiculite insulation in drywall in the sub-basement. Samples 238, 239, 240.			<b>Description:</b>	Asbestos-containing black glue dots behind mirror panels in the sub-basement. Samples 241, 242, 243.		
<b>Client:</b>	City of Oklahoma City, OK			<b>Client:</b>	City of Oklahoma City, OK		
<b>Photographer:</b>	Michael Dustman			<b>Photographer:</b>	Michael Dustman
