**HOMOGENEOUS MATERIALS LIST  
FIRST NATIONAL CENTER  
(WEST BUILDING-1931)  
120 NORTH ROBINSON AVENUE  
OKLAHOMA CITY, OKLAHOMA 73102**

### **POSITIVE ACM PHOTOGRAPHIC DOCUMENTATION**

**Positive ACM– West Building-1931, 120 N. Robinson Avenue, Oklahoma City, Oklahoma 73102**

# Asbestos Survey

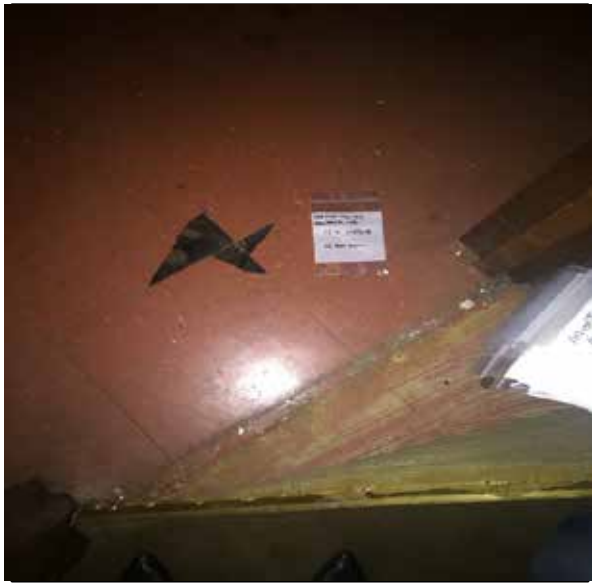
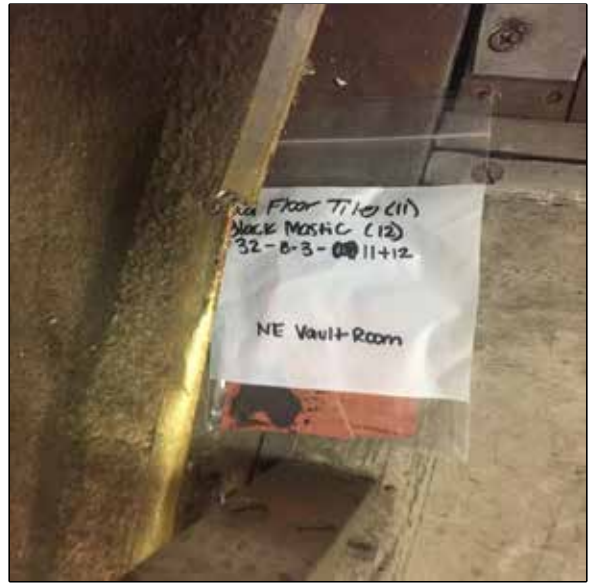
<b>Photograph Number:</b>	1	<b>Date:</b>	11/14/2016	<b>Photograph Number:</b>	2	<b>Date:</b>	11/14/2016
<b>Description:</b>	Asbestos-containing red floor tile 9"x9" with black mastic in the basement. Samples 7, 8, 9.			<b>Description:</b>	Asbestos-containing white 9"x9" floor tile with black mastic in the basement. Samples 10, 11, 12.		
<b>Client:</b>	City of Oklahoma City, OK			<b>Client:</b>	City of Oklahoma City, OK		
<b>Photographer:</b>	Jamie Marshall			<b>Photographer:</b>	Jamie Marshall

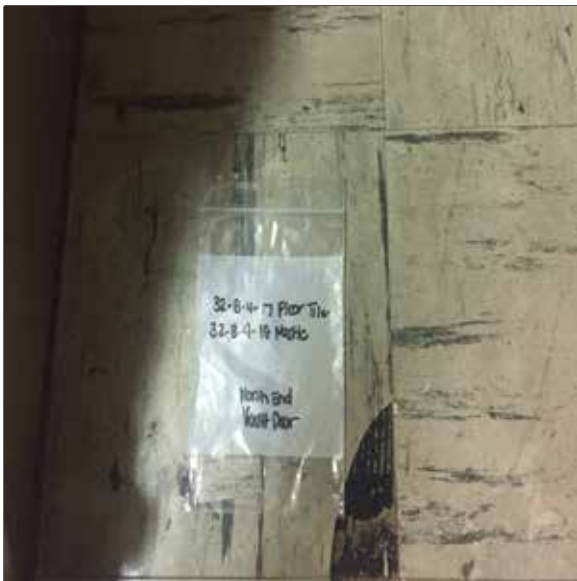
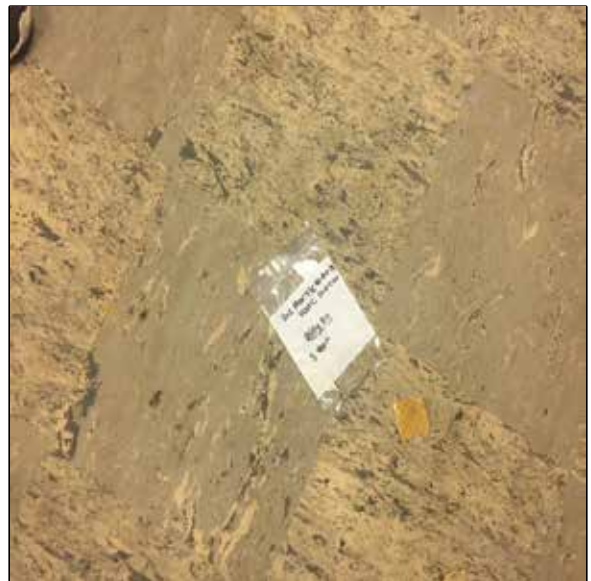
<b>Photograph Number:</b>	3	<b>Date:</b>	11/14/2016	<b>Photograph Number:</b>	4	<b>Date:</b>	11/14/2016
<b>Description:</b>	Asbestos-containing black 9"x9" floor tile with black mastic in the basement. Samples 16, 17, 18.			<b>Description:</b>	Asbestos-containing white marbled 12"x12" floor tile with black mastic in the basement. Samples 19, 20.		
<b>Client:</b>	City of Oklahoma City, OK			<b>Client:</b>	City of Oklahoma City, OK		
<b>Photographer:</b>	Jamie Marshall			<b>Photographer:</b>	Jamie Marshall

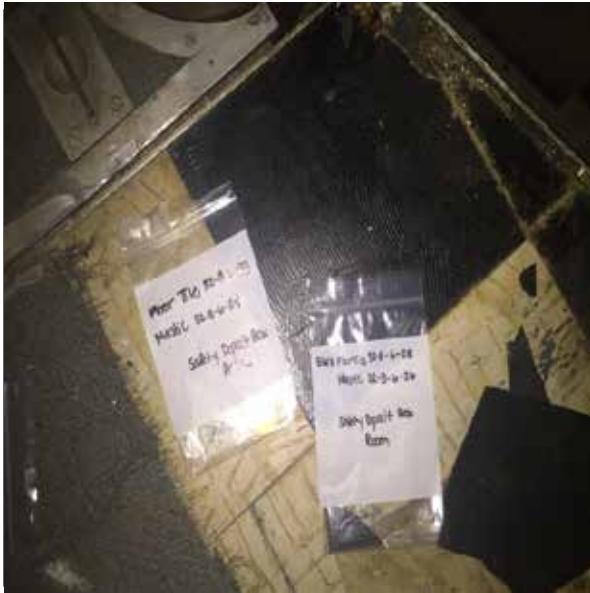
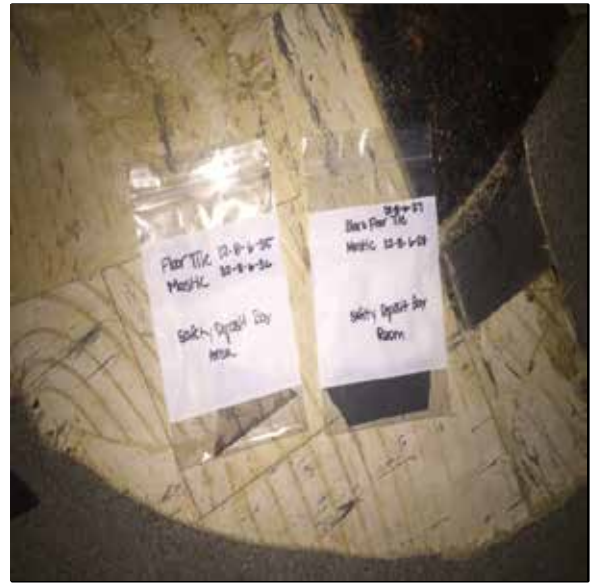
<b>Photograph Number:</b>	5	<b>Date:</b>	11/14/2016	<b>Photograph Number:</b>	6	<b>Date:</b>	11/15/2016
<b>Description:</b>	Asbestos-containing tan 12"x12" floor tile with black mastic in the basement. Samples 24, 25, 26.			<b>Description:</b>	Asbestos-containing grey 9"x9" floor tile with black mastic in the basement. Samples 27, 28, 29.		
<b>Client:</b>	City of Oklahoma City, OK			<b>Client:</b>	City of Oklahoma City, OK		
<b>Photographer:</b>	Jamie Marshall			<b>Photographer:</b>	Jamie Marshall

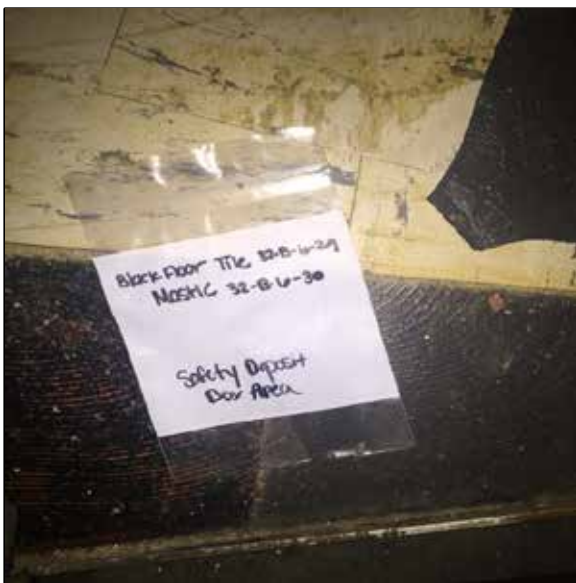
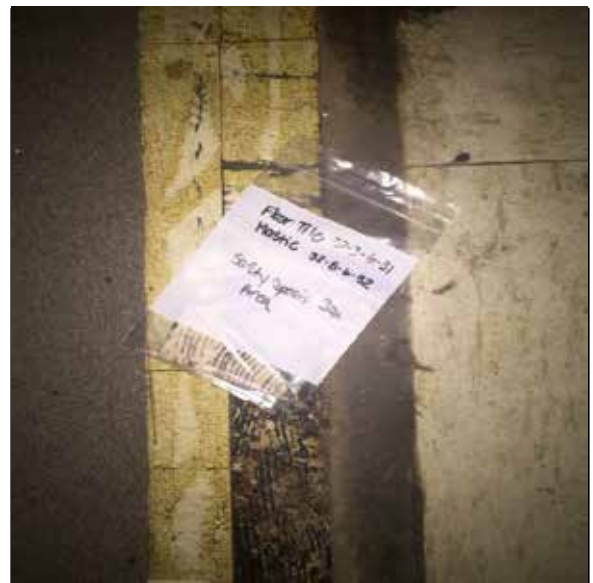
<b>Photograph Number:</b>	7	<b>Date:</b>	11/15/2016	<b>Photograph Number:</b>	8	<b>Date:</b>	11/16/2016
<b>Description:</b>	Asbestos-containing layered wall system in the basement. Sample 30.			<b>Description:</b>	Asbestos-containing layered wall system in the basement. Sample 32.		
<b>Client:</b>	City of Oklahoma City, OK			<b>Client:</b>	City of Oklahoma City, OK		
<b>Photographer:</b>	Jamie Marshall			<b>Photographer:</b>	Jamie Marshall

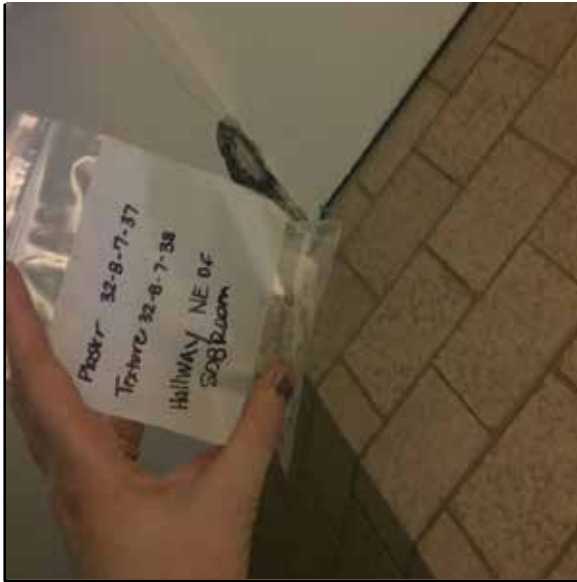
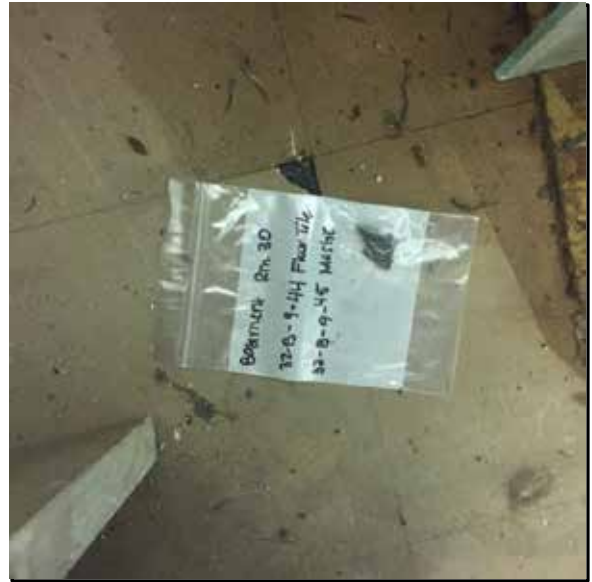
<b>Photograph Number:</b>	9	<b>Date:</b>	11/16/2016	<b>Photograph Number:</b>	10	<b>Date:</b>	11/16/2016
<b>Description:</b>	Asbestos-containing layered wall system on the 1 <sup>st</sup> floor. Samples 35, 36, 37.			<b>Description:</b>	Asbestos-containing black mastic and carpet glue on the 1 <sup>st</sup> floor. Samples 44, 45, 46.		
<b>Client:</b>	City of Oklahoma City, OK			<b>Client:</b>	City of Oklahoma City, OK		
<b>Photographer:</b>	Jamie Marshall			<b>Photographer:</b>	Jamie Marshall

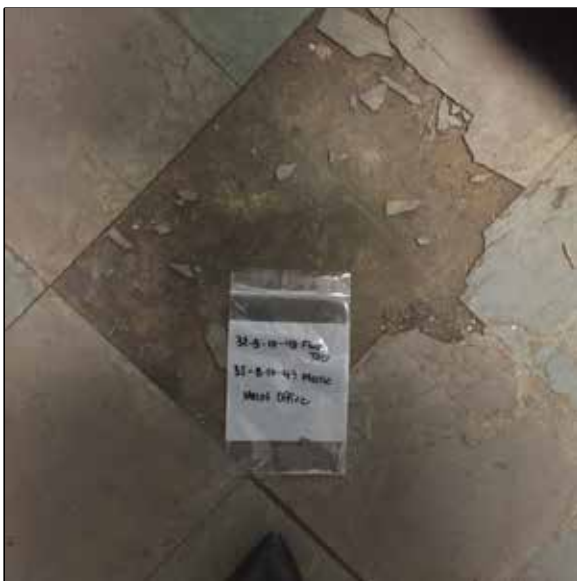
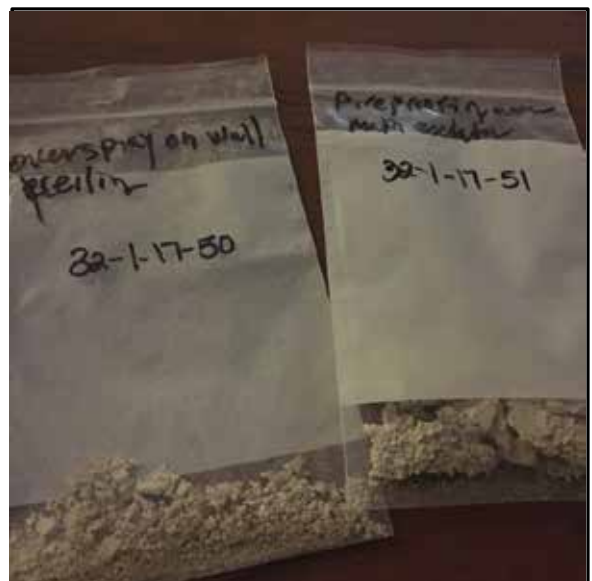
<b>Photograph Number:</b>	11	<b>Date:</b>	11/16/2016	<b>Photograph Number:</b>	12	<b>Date:</b>	11/16/2016
<b>Description:</b>	Asbestos-containing mirror mastic on the 1 <sup>st</sup> floor. Samples 47, 48, 49.			<b>Description:</b>	Asbestos-containing fireproofing overspray on the 1 <sup>st</sup> floor. Sample 50.		
<b>Client:</b>	City of Oklahoma City, OK			<b>Client:</b>	City of Oklahoma City, OK		
<b>Photographer:</b>	Jamie Marshall			<b>Photographer:</b>	Jamie Marshall

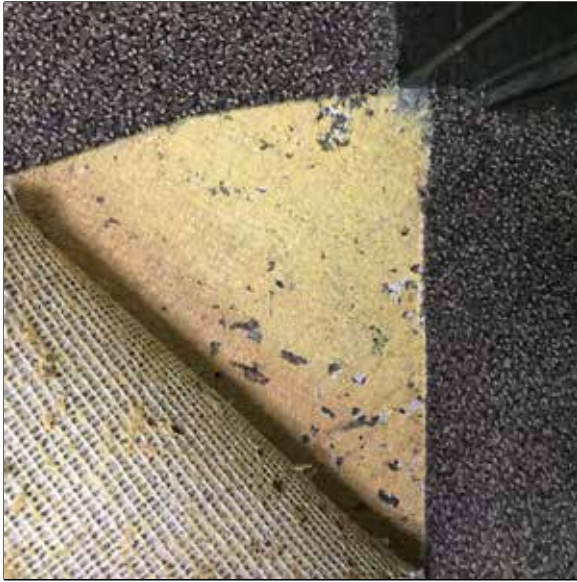
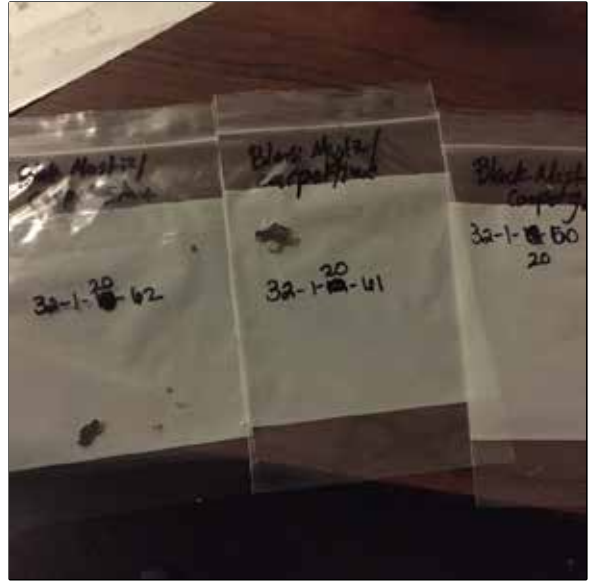
<b>Photograph Number:</b>		13	<b>Date:</b>		11/16/2016
<b>Description:</b>		Asbestos-containing black mastic and carpet glue on 1 <sup>st</sup> floor. Sample 60.			
<b>Client:</b>		City of Oklahoma City, OK			
<b>Photographer:</b>		Jamie Marshall			
<div>NO PHOTOGRAPH COLLECTED</div>

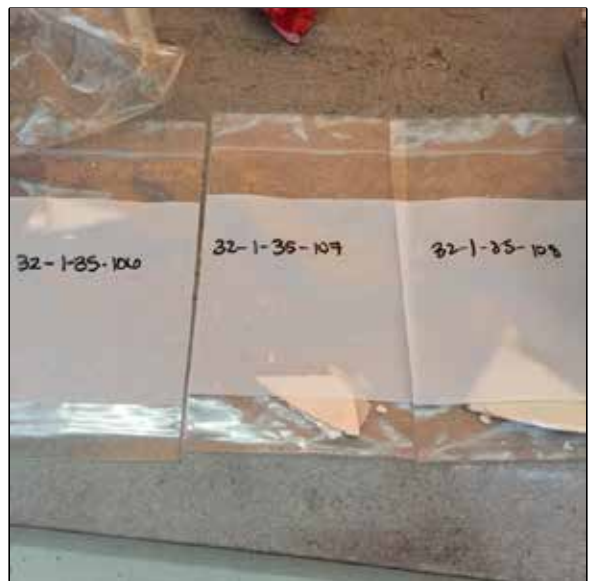
<b>Photograph Number:</b>		16	<b>Date:</b>		11/16/2016
<b>Description:</b>		Asbestos-containing beige floor tile and black mastic on the 1 <sup>st</sup> floor. Samples 106, 107, 108.			
<b>Client:</b>		City of Oklahoma City, OK			
<b>Photographer:</b>		Jamie Marshall

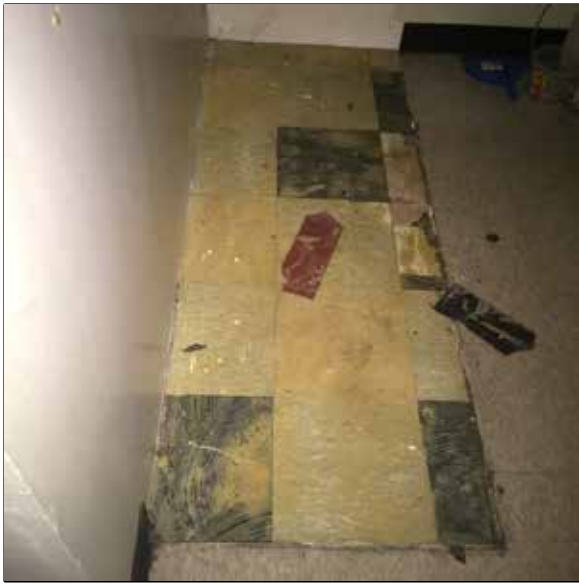
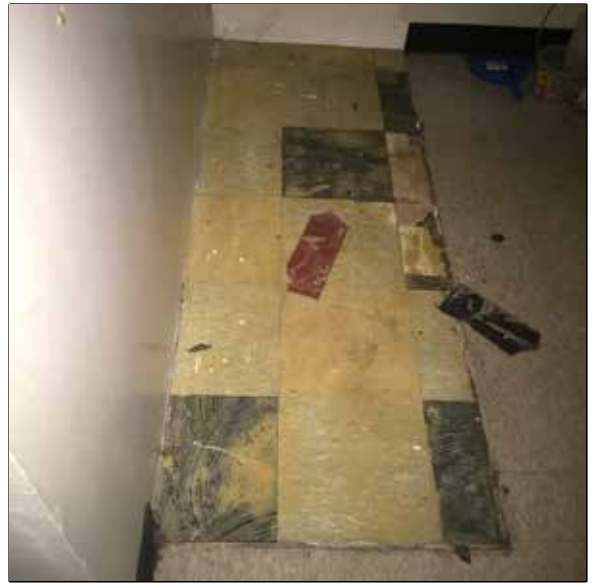
<b>Photograph Number:</b>	17	<b>Date:</b>	11/16/2016	<b>Photograph Number:</b>	18	<b>Date:</b>	11/16/2016
<b>Description:</b>	Asbestos-containing pink floor tile with yellow and black mastic on the 1 <sup>st</sup> floor. Samples 127, 128, 129.			<b>Description:</b>	Asbestos-containing beige floor tile with black and yellow mastic on the 1 <sup>st</sup> floor. Samples 130, 131, 132.		
<b>Client:</b>	City of Oklahoma City, OK			<b>Client:</b>	City of Oklahoma City, OK		
<b>Photographer:</b>	Jamie Marshall			<b>Photographer:</b>	Jamie Marshall

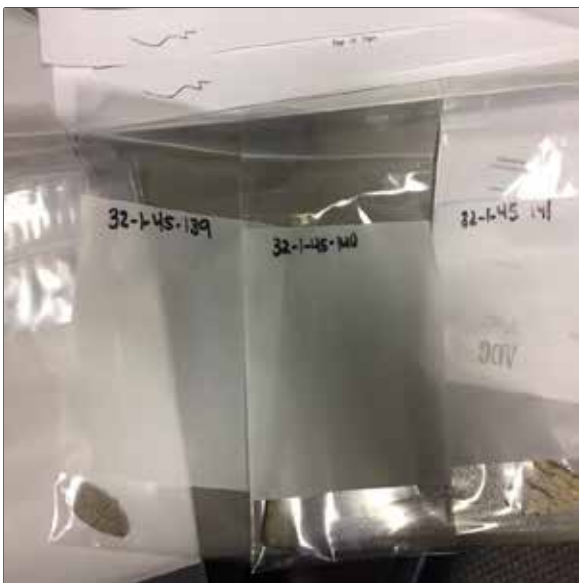
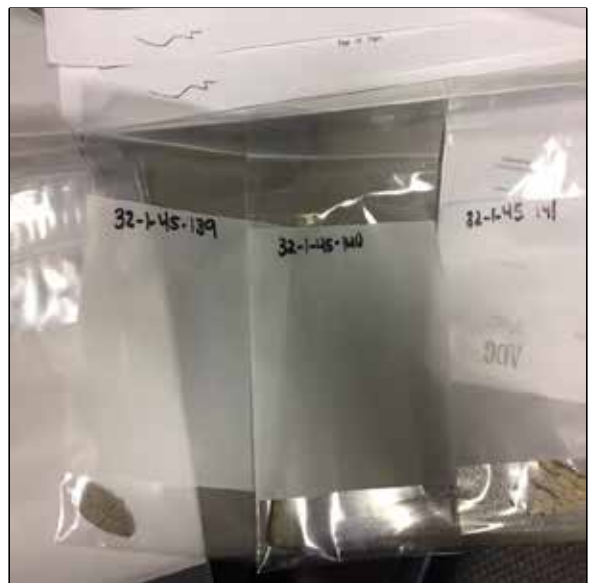
<b>Photograph Number:</b>	19	<b>Date:</b>	11/16/2016	<b>Photograph Number:</b>	20	<b>Date:</b>	11/16/2016
<b>Description:</b>	Asbestos-containing 12"x12" beige floor tile with black and yellow mastic on 1 <sup>st</sup> floor. Samples 139, 140.			<b>Description:</b>	Asbestos-containing beige 12"x12" floor tile with black and yellow mastic on the 1 <sup>st</sup> floor. Samples 141.		
<b>Client:</b>	City of Oklahoma City, OK			<b>Client:</b>	City of Oklahoma City, OK		
<b>Photographer:</b>	Jamie Marshall			<b>Photographer:</b>	Jamie Marshall

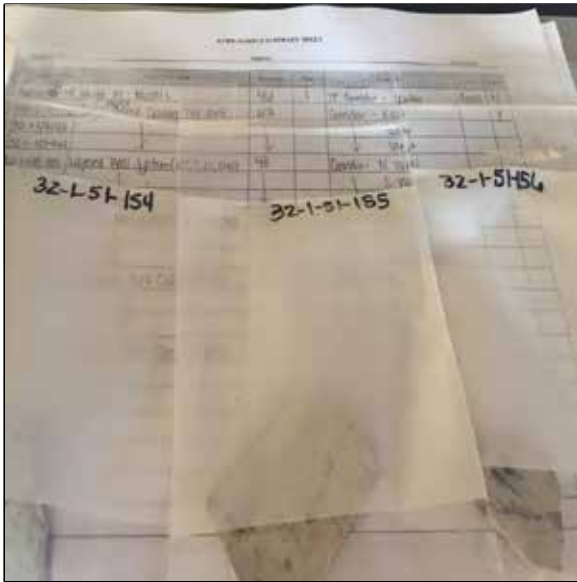
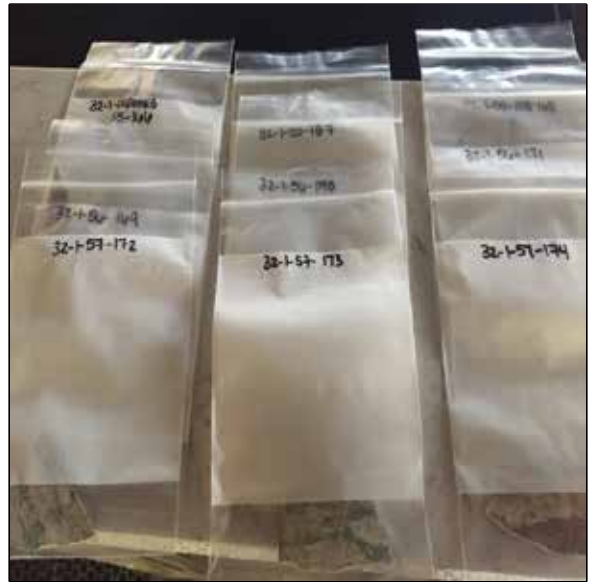
<b>Photograph Number:</b>	21	<b>Date:</b>	11/16/2016	<b>Photograph Number:</b>	22	<b>Date:</b>	11/16/2016
<b>Description:</b>	Asbestos-containing white 12"x12" marbled floor tile and yellow mastic on the first floor. Samples 154, 155, 156.			<b>Description:</b>	Asbestos-containing green speckle 11' with black mastic on the first floor. Samples 172, 173, 174.		
<b>Client:</b>	City of Oklahoma City, OK			<b>Client:</b>	City of Oklahoma City, OK		
<b>Photographer:</b>	Jamie Marshall			<b>Photographer:</b>	Jamie Marshall

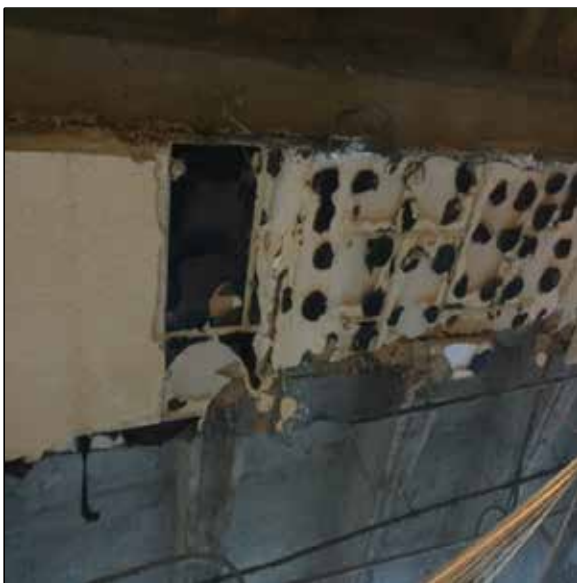
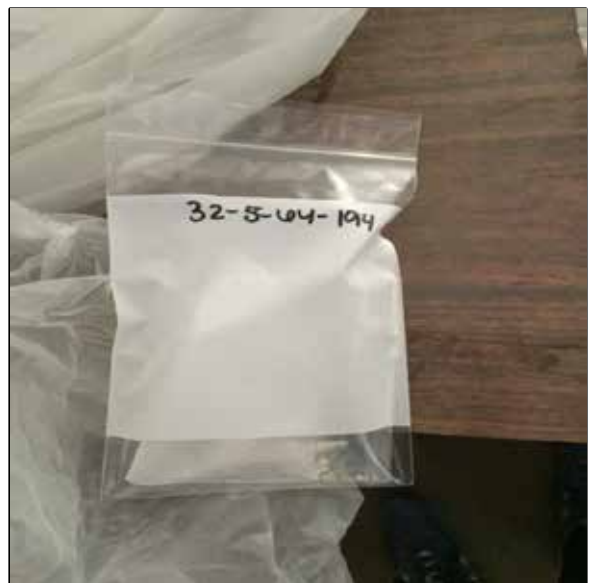
<b>Photograph Number:</b>	23	<b>Date:</b>	11/16/2016	<b>Photograph Number:</b>	24	<b>Date:</b>	11/16/2016
<b>Description:</b>	Asbestos-containing layered wall system on the 4 <sup>th</sup> floor. Samples 181, 182, 183.			<b>Description:</b>	Asbestos-containing layered wall system on the 5 <sup>th</sup> floor. Samples 193, 194.		
<b>Client:</b>	City of Oklahoma City, OK			<b>Client:</b>	City of Oklahoma City, OK		
<b>Photographer:</b>	Jamie Marshall			<b>Photographer:</b>	Jamie Marshall

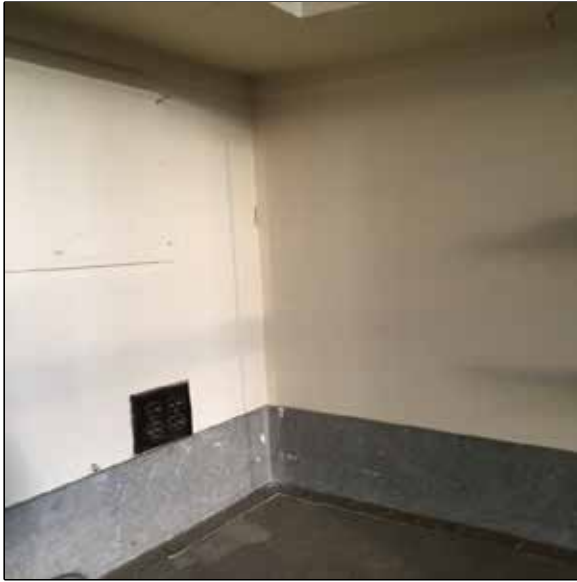
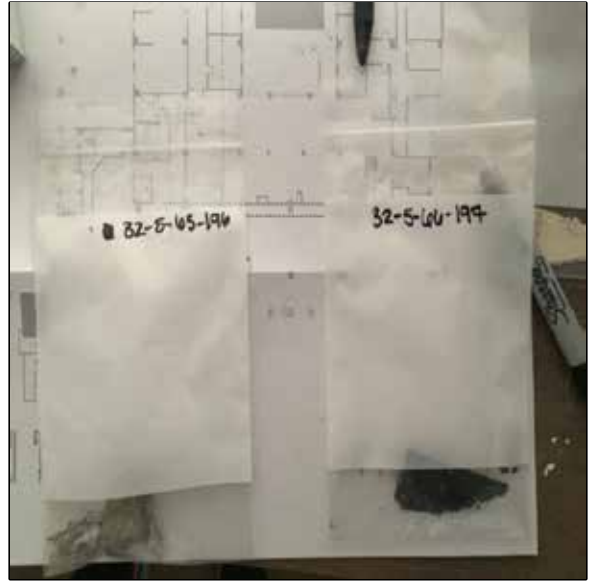
<b>Photograph Number:</b>	25	<b>Date:</b>	11/16/2016	<b>Photograph Number:</b>	26	<b>Date:</b>	11/16/2016
<b>Description:</b>	Layered wall system on the 5 <sup>th</sup> floor. Sample 195.			<b>Description:</b>	Asbestos-containing white cement board canter on the 5 <sup>th</sup> floor. Sample 196.		
<b>Client:</b>	City of Oklahoma City, OK			<b>Client:</b>	City of Oklahoma City, OK		
<b>Photographer:</b>	Jamie Marshall			<b>Photographer:</b>	Jamie Marshall

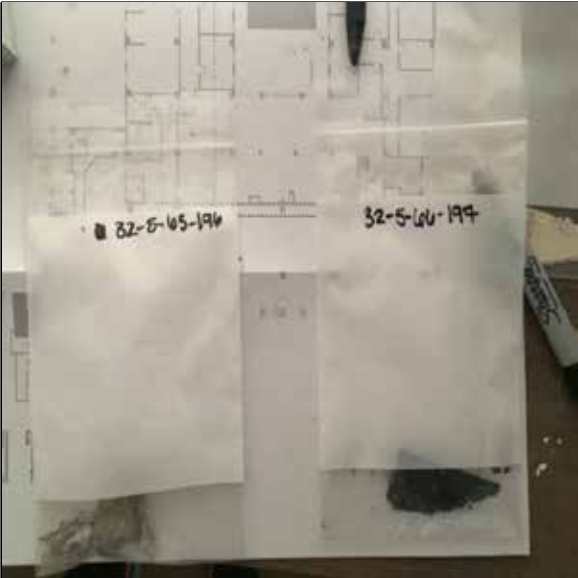
<div>NO PHOTOGRAPH COLLECTED</div>			
<b>Photograph Number:</b>	27	<b>Date:</b>	11/16/2016	<b>Photograph Number:</b>	28	<b>Date:</b>	11/16/2016
<b>Description:</b>	Asbestos-containing gray cement board. Sample 196 and 197.			<b>Description:</b>	Asbestos-containing layered wall system. Sample 340, 341, and 342.		
<b>Client:</b>	City of Oklahoma City, OK			<b>Client:</b>	City of Oklahoma City, OK		
<b>Photographer:</b>	Jamie Marshall			<b>Photographer:</b>	Jamie Marshall

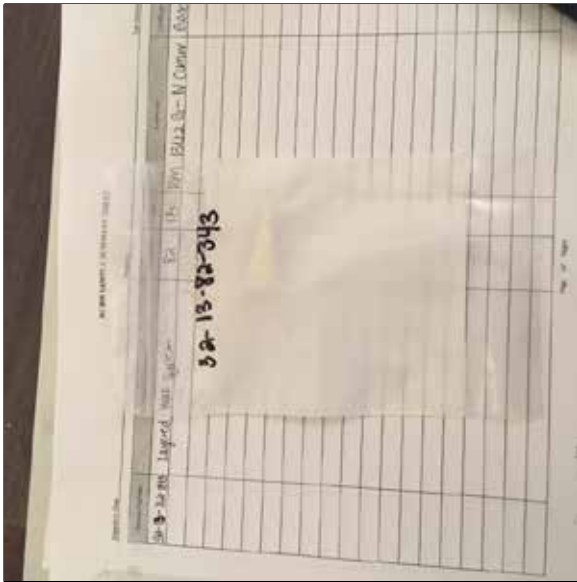
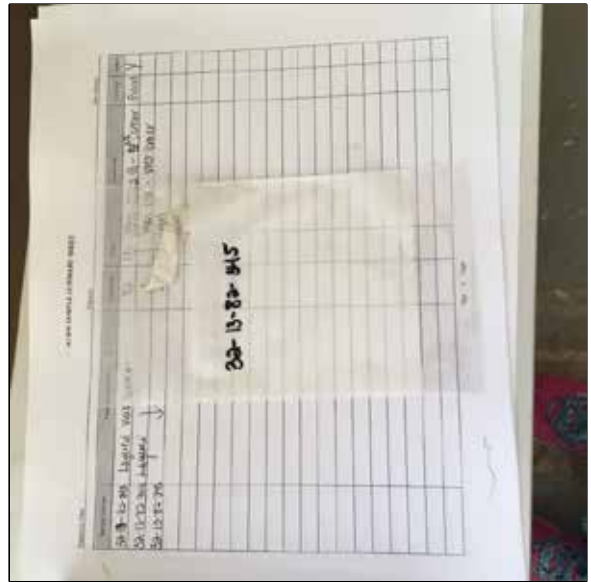
<b>Photograph Number:</b>	29	<b>Date:</b>	11/16/2016	<b>Photograph Number:</b>	30	<b>Date:</b>	11/16/2016
<b>Description:</b>	Asbestos-containing sink undercoating black. Sample 343.			<b>Description:</b>	Asbestos-containing layered wall system. Sample 344, 345 and 346.		
<b>Client:</b>	City of Oklahoma City, OK			<b>Client:</b>	City of Oklahoma City, OK		
<b>Photographer:</b>	Jamie Marshall			<b>Photographer:</b>	Jamie Marshall		
<div>NO PHOTOGRAPH COLLECTED</div>

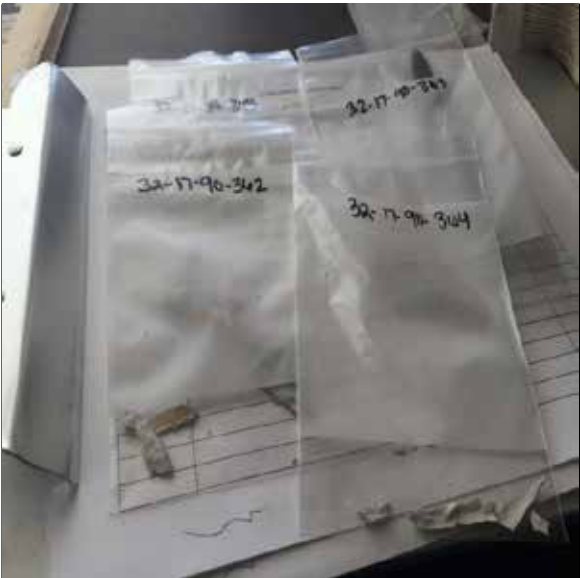
<b>Photograph Number:</b>	31	<b>Date:</b>	11/16/2016	<b>Photograph Number:</b>	32	<b>Date:</b>	11/16/2016
<b>Description:</b>	Asbestos-containing layered wall system. Sample 356.			<b>Description:</b>	Asbestos-containing wall texture on plaster. Sample 362, 363, and 364.		
<b>Client:</b>	City of Oklahoma City, OK			<b>Client:</b>	City of Oklahoma City, OK		
<b>Photographer:</b>	Jamie Marshall			<b>Photographer:</b>	Jamie Marshall

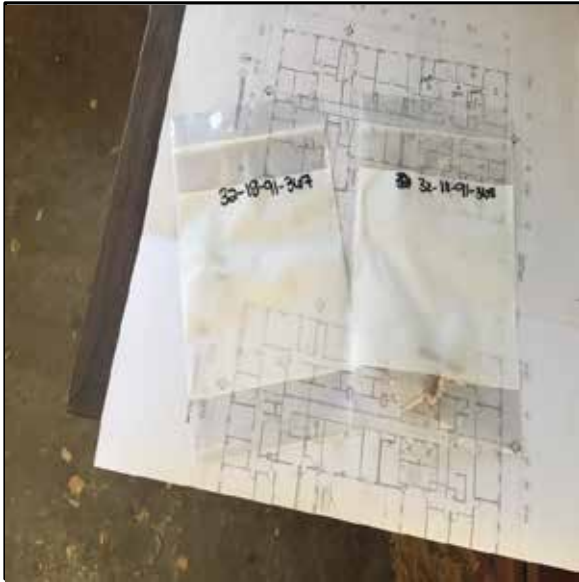
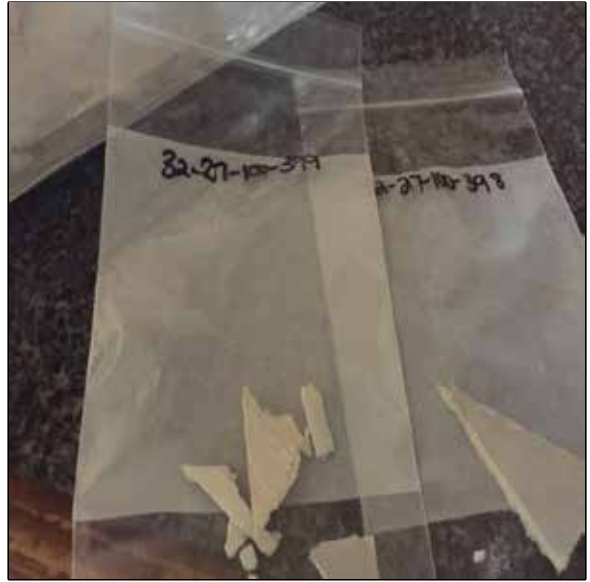
<b>Photograph Number:</b>		33	<b>Date:</b>		11/16/2016	<b>Photograph Number:</b>		34	<b>Date:</b>		11/16/2016						
<b>Description:</b>		Asbestos-containing layered wall system. Sample 367.				<b>Description:</b>		Asbestos-containing layered wall system. Sample 398.									
<b>Client:</b>		City of Oklahoma City, OK				<b>Client:</b>		City of Oklahoma City, OK									
<b>Photographer:</b>		Jamie Marshall				<b>Photographer:</b>		Jamie Marshall									
 						<div>NO PHOTOGRAPH COLLECTED</div>											
<b>Photograph Number:</b>												35	<b>Date:</b>		11/16/2016		
<b>Description:</b>		Asbestos-containing layered wall system. Sample 407.										<b>Description:</b>		Asbestos-containing popcorn ceiling texture. Sample 417.			
<b>Client:</b>		City of Oklahoma City, OK										<b>Client:</b>		City of Oklahoma City, OK			
<b>Photographer:</b>		Jamie Marshall				<b>Photographer:</b>		Jamie Marshall
