WHERE DID MY NAMEPLATE GO?

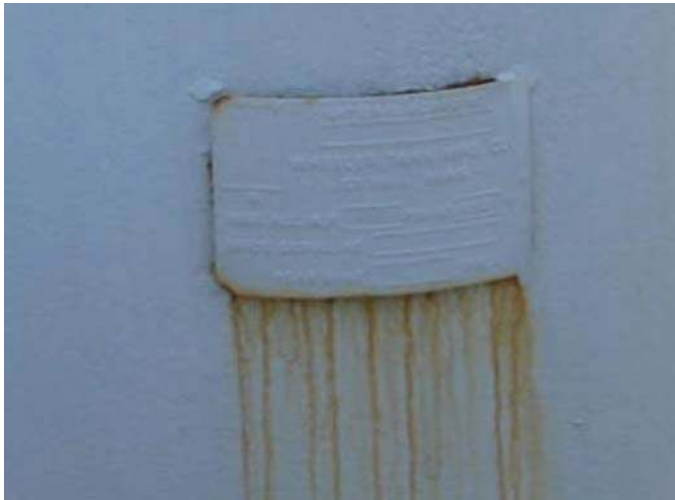
This story starts with a nameplate that was originally tack welded to the pressure vessel as was often done back “in the day.” Over time, water worked its way underneath the nameplate and began to corrode the vessel. In an effort to deal with this, the facility removed the nameplate in order to clean up the corrosion and stop it by painting the vessel. For a time, this nameplate was lost, until the facility maintenance manager was cleaning out a drawer in his desk and he happened upon it. Realizing that it needed to stay with the vessel, he had it secured near the vessel using wire. An admirable thought, but it is an epic fail.

First, the National Board Inspection Code states that: “When the stamping on a pressure-retaining item becomes indistinct or the nameplate is lost, illegible, or detached, but traceability to the original pressure-retaining item is still possible, the Inspector shall instruct the owner or user to have the nameplate or stamped data replaced.” First off, an

inspector will require that this nameplate be replaced. Second, the key lies in the traceability. If the facility has the original manufacturer’s data sheet and, preferably, the original drawing as well, then traceability is fairly easy and approval for installing a replacement nameplate is fairly easy. The real issue come to bear when the documentation for the vessel cannot be obtained, whether because the original nameplate was lost after it became detached, or because the vessel was not registered with the National Board and the manufacturer is long since out of business. When this happens, it becomes very difficult and expensive to have a professional engineer re-certify an existing vessel in order for a new nameplate to be fabricated and attached.

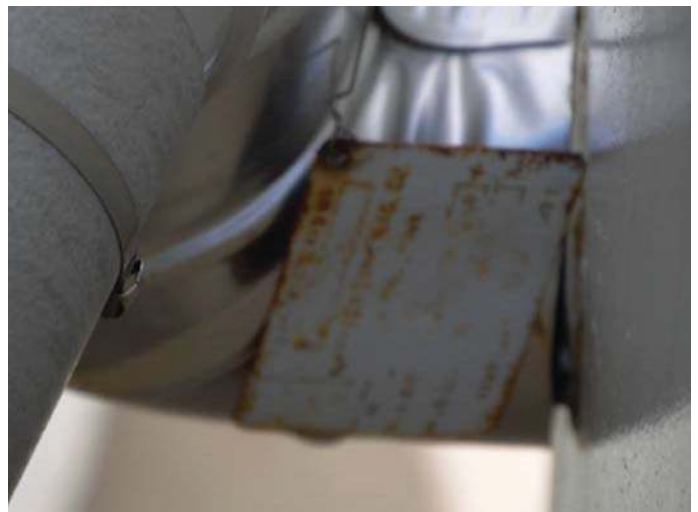
Let’s say that the manufacturer’s documentation for the vessel is available. Should this be the case, a new nameplate can be fabricated and applied by someone holding an R

stamp from the National Board. The application of the new nameplate must be witnessed by a National Board commissioned inspector. All of this costs money.

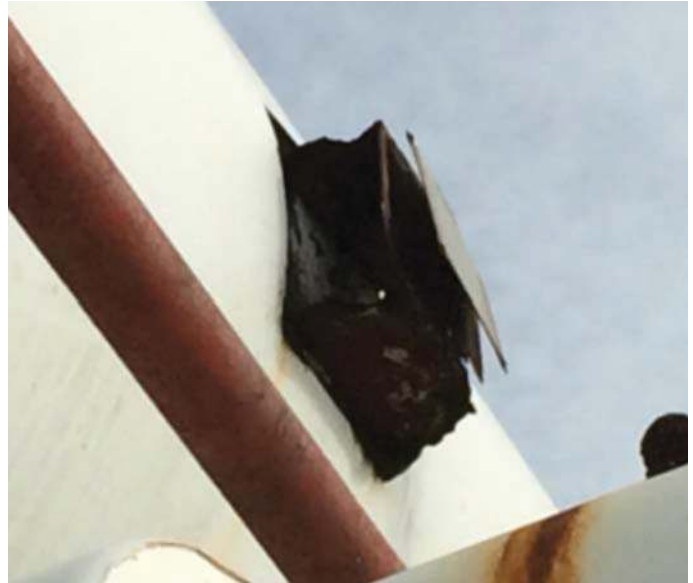
Here's the rub. The National Board Inspection Code states that: "Permission from the Jurisdiction is not required for the reattachment of nameplates that are partially attached. So, if a nameplate is still partially attached, as in the photo below, it can be reattached using rivets or screws by facility personnel and it does not need to be inspected by a National Board commission inspector.

So, it pays to inspect the nameplates of your vessels, particularly if they are hidden under insulation. Because once they fall off completely, the real problems start. In addition, it pays to identify corrosion before it leads to material loss so that it may be cleaned up and arrested before it affects the safe working pressure of the vessel.
