the source turned into a real detective activity.

By ANTHONY J. MAGGIO, SCS Engineers and ALAN BACOCK, Big Pine Indian Reservation

#### Environmental assessment

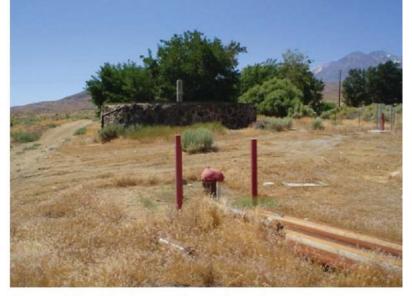
The proximity of the former cistern to the water supply well can be seen in this photo.

- An old, exposed subterranean water tank, situated next to the
  well field about 20 feet away in the downgradient direction.
  The tank was formerly covered, but had been left open for
  years. The bottom of the tank showed evidence of random
  dumping. The tank was viewed as a possible source of PCE
  because of its proximity to the well field.
