### Extending the Useful Life of Your Tipping Floor

Owners have more choices than ever to protect their floors from excessive wear. Protective toppings have proven to be a wise investment in maintaining the uptime and longevity of your facility and reducing unnecessary extra expenditures on floor repairs or replacement.

■ By Bruce Clark, P.E.

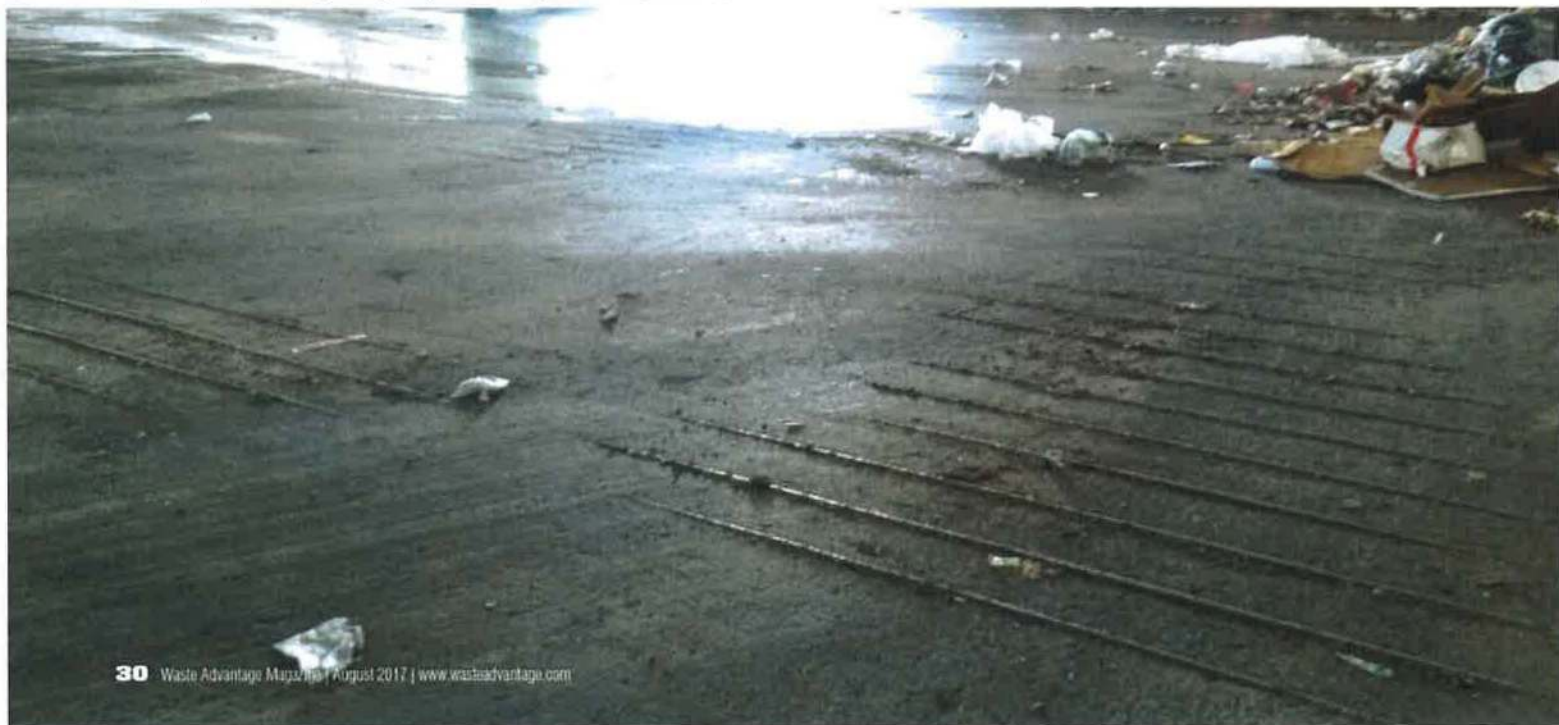
Figure 1: Exposed reinforcing bars signal repair is necessary. Photo courtesy of SCS Engineers.

Together, the two degradation processes rapidly accelerate the erosion of the floor. The cement breaks down and is weakened, and is further destroyed by the abrasive action. The floor surface is literally worn away—up to approximately  $\frac{3}{4}$ " annually is not uncommon. Within about three years, the wear can be so significant that the top bars of the reinforcing steel mat are exposed, usually correlated to a loss of at least 2" to 2-1/2" of concrete (see Figure 1).

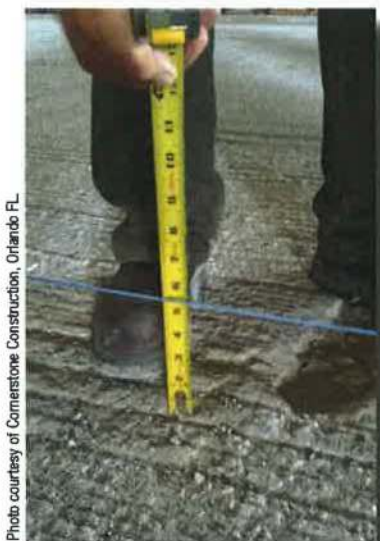
**Figure 2:**  
Start of repairs – grinding existing concrete.

A general summary of the advantages and potential concerns are provided in Table 1. Keep in mind that most all floor toppings will require that the base substrate be prepared to accept the topping and this will add to the cost. This usually involves high pressure washing and scarifying the substrate with traditional concrete grinding equipment to provide a good bond for the new materials (Figure 2).

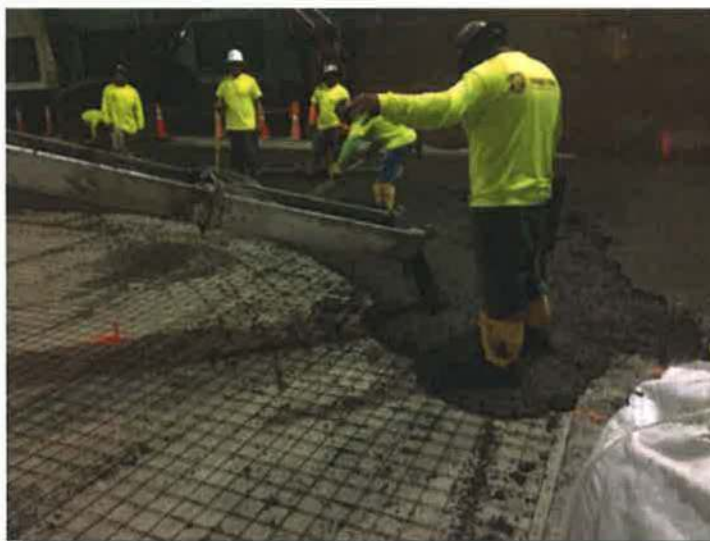
**Figure 3:** Pouring a topping with hard mineral aggregate.

The "A" products typically work best in a thickness from about 3/4" up to 2", or more in some special cases (Figure 3, page 34). The "B" products are installed thinner, typically 1/4" to 1/2". Type "C" product is adaptable to a thickness up to 12".

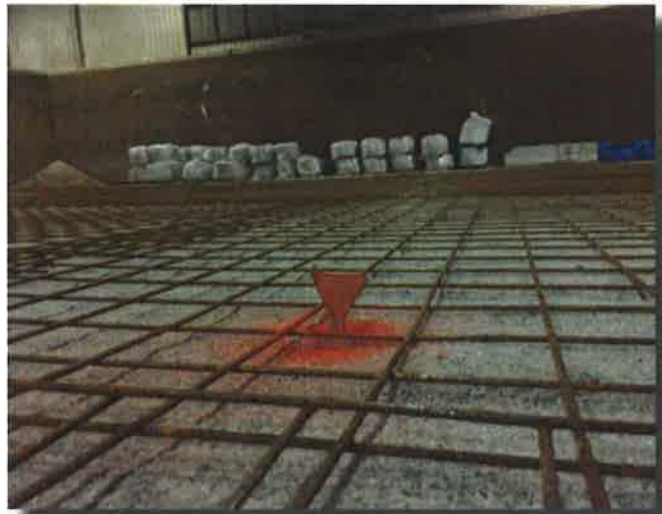
**Figure 5:** Floor wear indicator. Photo courtesy of Cornerstone Construction, Orlando FL.

Keep in mind that the wear indicator devices installed with the topping will eventually start to show themselves in the heaviest use areas (Figure 5). Do not ignore them. Once the wear indicator shows, the floor has lost approximately 1/2" from the original surface. This is your call to start planning to restore the topping in that area. Ideally, this should be conducted within the next year; otherwise, you will run the risk of continuing to wear the floor away. The cost of the topping restoration goes up rapidly as the topping replacement thickness increases.
