ICE BUILD UP

The subject of this edition of Epic Fails is excessive ice buildup. This is a topic that is frequently discussed (some would say argued). I personally have seen a regulatory inspector freak out, to use the colloquial term, over a thin layer of frost on a product tank surge drum. I think that few who actually work in our industry would think that that would be excessive.

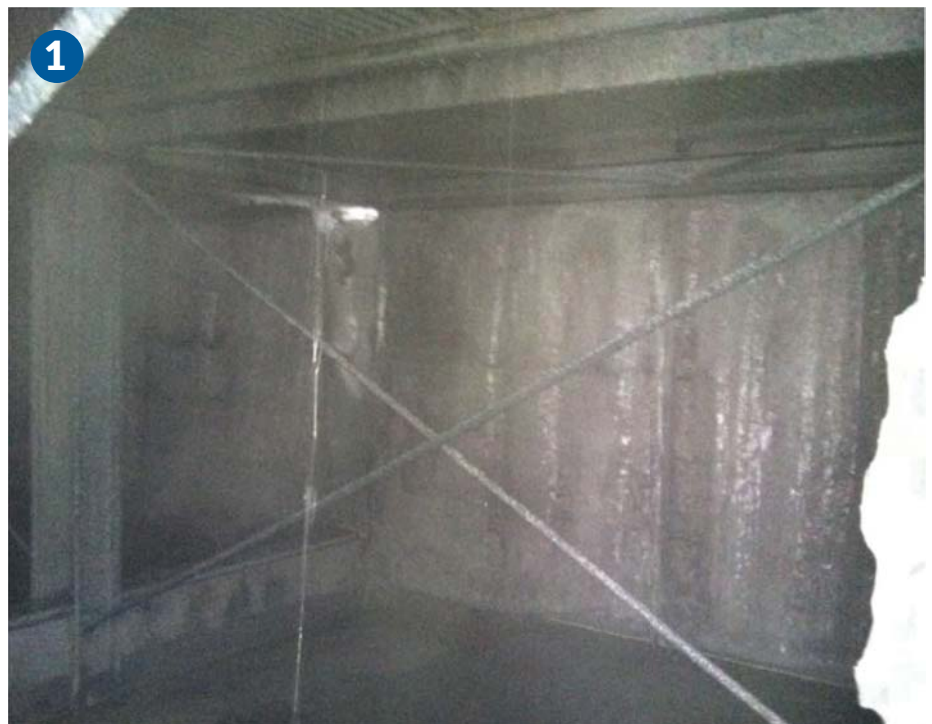
So let's look at some examples of what could be construed as excessive ice buildup. Do you recognize what is shown in the first picture, shown below? It is a view into an evaporative condenser that is completely frozen over. This occurred during the fall in a northern state. Each time that the facility attempted to turn the water off, the discharge pressure would jump up and they turned the water back on. The reason for the jump in pressure was not properly investigated until the airflow

became so choked that the system could no longer be run without risking a release. When the first drift eliminator was removed, the airflow through the opening was so strong that it pulled a person's hard hat off. Now some might argue that this ice buildup might not meet the criteria spelled out in IIAR 6 for excessive ice buildup, but without true engineering calculations, how can we disprove that this ice buildup negatively impacted the structural integrity of the condenser?

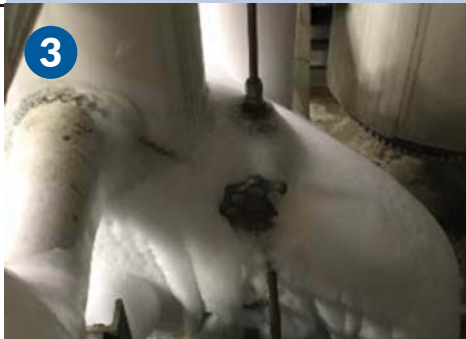
In the third photo, you can at least see the pump in question, but the isolation valve would be difficult, at best, to operate in an emergency.

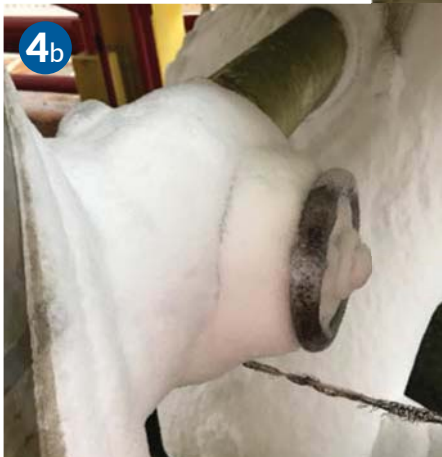
The next two photos provide some clear examples where the ice buildup interferes with the operation of emergency shut off valves.

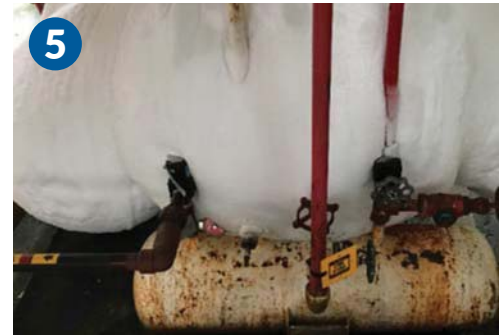
Finally, the last photo represents ice buildup that borders on being an imminent threat. As the ice buildup envelopes that small bore piping and valves on the oil pot, it will begin the bend and deflect them, potentially causing a catastrophic release of ammonia.

The owner is permitted to develop and incorporate defrost operational procedures, ice removal procedures using mechanical tools, or both, with determined frequencies to safely remove ice often enough to avoid excess accumulation.

Bear this in mind when developing your inspections for your system's mechanical integrity program. Always be mindful of the potential consequences of ice buildup, particularly if it is allowed to continue for an extended period of time.
