# **ANALYSIS FOR BROWNFIELDS CLEANUP ALTERNATIVES FOR THE FIRST NATIONAL CENTER ABATEMENT PROJECT**

**First National Center  
120 North Robinson  
Oklahoma City, Oklahoma**

**February 6, 2017**

**SCS Engineers and Family Environmental Services**

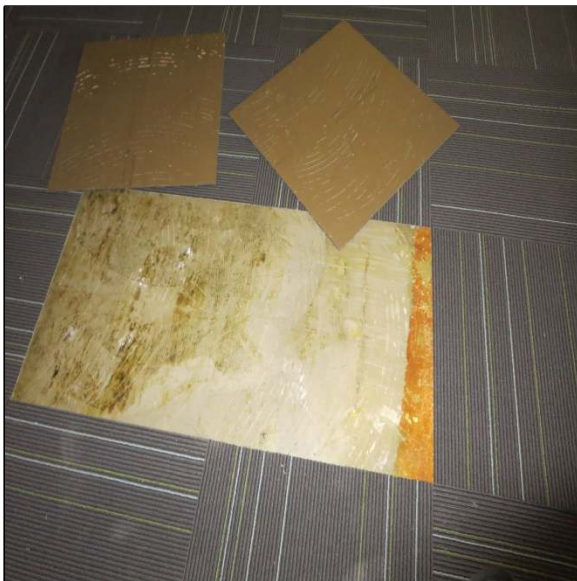
<b>Photograph Number:</b>	7	<b>Date:</b>	11/15/2016	<b>Photograph Number:</b>	8	<b>Date:</b>	11/16/2016
<b>Description:</b>	Asbestos-containing black mastic under gray floor filler on the 7 <sup>th</sup> floor. Samples 61, 62, 63.			<b>Description:</b>	Asbestos-containing texture on a wall in Feed the Children on the 1 <sup>st</sup> floor. Sample 117.		
<b>Client:</b>	City of Oklahoma City, OK			<b>Client:</b>	City of Oklahoma City, OK		
<b>Photographer:</b>	Michael Dustman			<b>Photographer:</b>	Michael Dustman

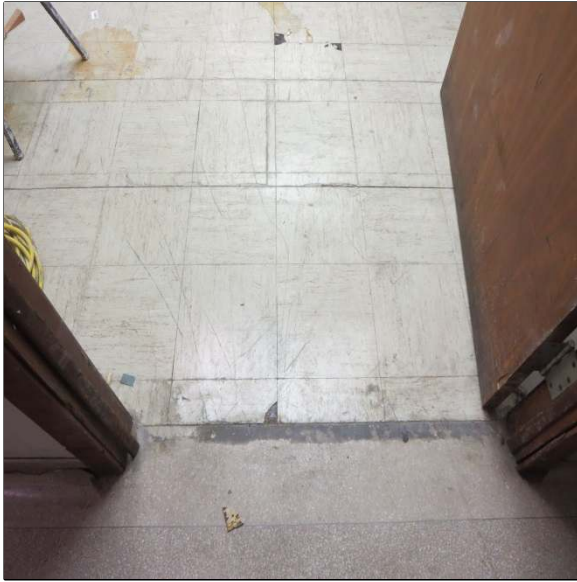
<b>Photograph Number:</b>	13	<b>Date:</b>	11/16/2016	<b>Photograph Number:</b>	14	<b>Date:</b>	11/16/2016
<b>Description:</b>	Asbestos-containing black mastic under tan with red streaked floor tile in the basement. Samples 196, 197, 198.			<b>Description:</b>	Asbestos-containing black mastic under tan with tan streaked floor tile in the basement. Samples 199, 200, 201.		
<b>Client:</b>	City of Oklahoma City, OK			<b>Client:</b>	City of Oklahoma City, OK		
<b>Photographer:</b>	Michael Dustman			<b>Photographer:</b>	Michael Dustman

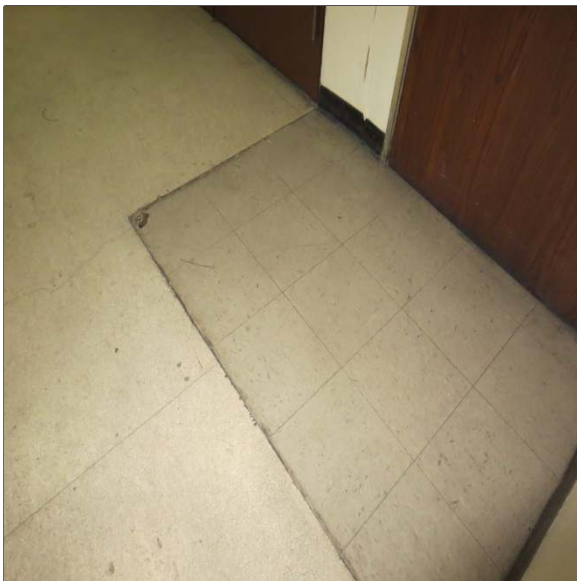
<b>Photograph Number:</b>	15	<b>Date:</b>	11/16/2016	<b>Photograph Number:</b>	16	<b>Date:</b>	11/16/2016
<b>Description:</b>	Asbestos-containing black mastic under gray floor tile in the basement. Samples 217, 218, 219.			<b>Description:</b>	Asbestos-containing texture on a wall by the basement escalator. Samples 226, 227, 228.		
<b>Client:</b>	City of Oklahoma City, OK			<b>Client:</b>	City of Oklahoma City, OK		
<b>Photographer:</b>	Michael Dustman			<b>Photographer:</b>	Michael Dustman
